Manhole Inspection Summary

Manhole # S71G1_021MH

Location Address: **6548 Riverview Ave.**

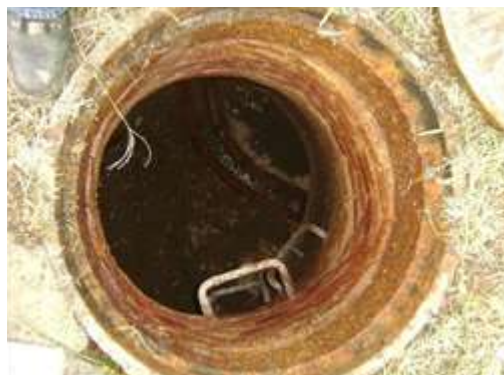
Top View

Condition: ☐ Sound ☐ Cracked ☐ Root Intrusion ☒ **Loose Brick** ☐ Deteriorated

Infiltration: ☐ None ☐ Joint ☐ Cracks ☒ **Mortar** ☐ Roots ☐ Wall

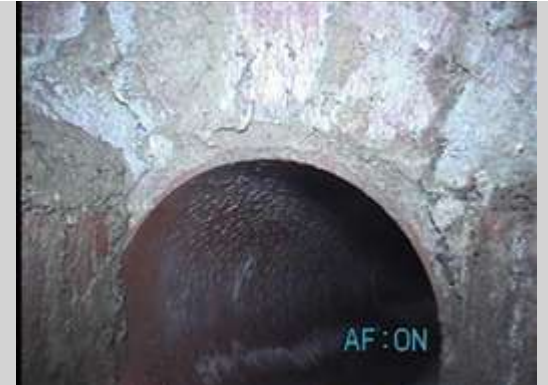
12 O'Clock Outflow

8 in. Circular Gravity Sewer
Pipe Out @ 12 O'Clock

Pipe Height: **8.4** (in.) Rod and Bar (Angled)
Pipe Material: **Clay** ☐ Pipe Lined
Invert Depth: **8.83** (ft.) Flow Characteristics: **None**
Deposits: ☒ None ☐ Mud ☐ Sludge ☐ Debris ☐ Grease
Silt Depth: (in.) Deposits Extent:
Infiltration: **None** Pipe Seal Cond: **Sound**

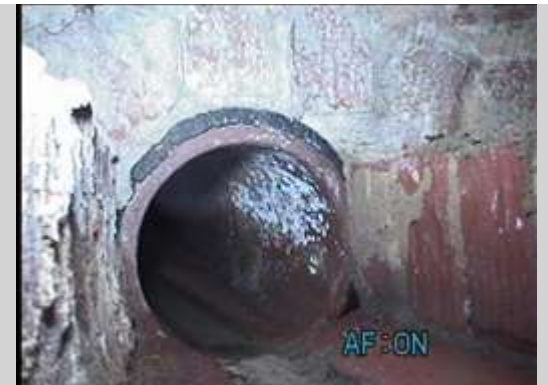
3 O'Clock Inflow

8 in. Circular Gravity Sewer
Pipe In @ 3 O'Clock

Pipe Height: **8.4** (in.) Rod and Bar (Angled)
Pipe Material: **Clay** ☐ Pipe Lined
Invert Depth: **8.67** (ft.) Flow Characteristics: **None**
Deposits: ☒ None ☐ Mud ☐ Sludge ☐ Debris ☐ Grease
Silt Depth: (in.) Deposits Extent:
Infiltration: **None** Pipe Seal Cond: **Sound**

Connects To: **House connection / Service line**
